This young sapling presents an opportunity to correct some structural concerns with much more ease than in the future when it would be larger & taller.

This tree is much older and larger than the one portrayed in the first example (Fall Newsletter). Larger trees generally require more work to correct problems and redistribute the shape of the crown as desired. Multiple rejuvenation pruning treatments are needed for this tree, and it will take several years to complete. Ideally, pruning to correct problems should be started when the tree is younger and smaller.

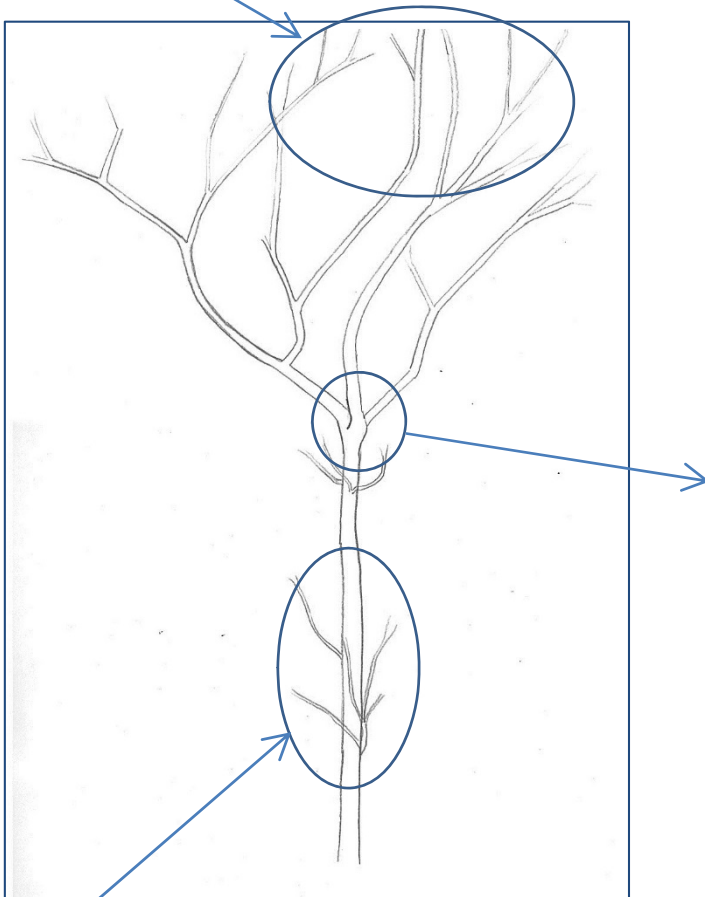
Dense growth in the central part of crown. The tree has favored growth in the vertical direction. More Lateral growth is preferable for fruit production.

To begin, Bruce points-out that the tree has favored using its energy toward vertical growth rather than lateral growth. Lateral growth is more conducive to producing fruit when a tree has plenty of space like this one. His recommendation is to shift this balance, and also reduce the dense concentration of growth near the center of the crown.

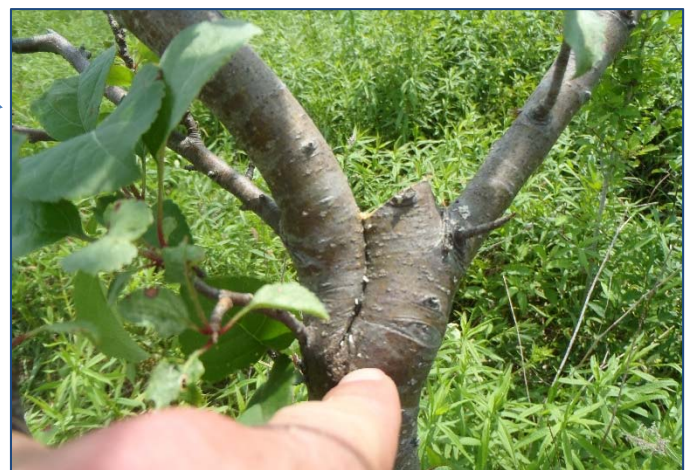
Epicormic sprouts on bole will be left to protect the bark from buck rubs. They'll be removed in the future.

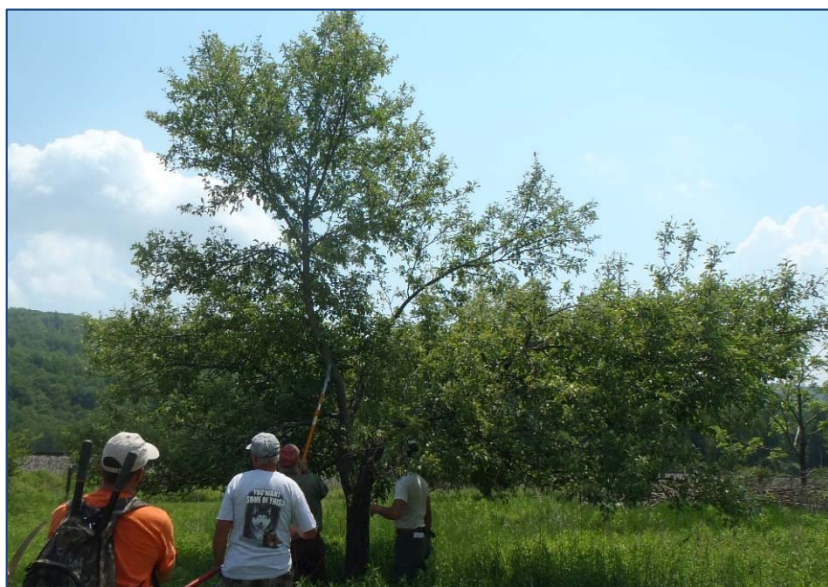
The next step is to determine how to best accomplish these goals with as little stress on the tree as possible. After close examination Bruce found a bad union between two of the more dominant stems. One or the other needed to be removed to avoid structural failure in the future.

Included bark was forming at the union of two dominant stems. The larger stem left behind will now grow freely and develop a strong union. Two lesser branches are left to grow freely. They do not impose upon the remaining dominant stem.

By removing the co-dominant stem on the right multiple things are accomplished:

- Chances of structural problems & breakage at the union are reduced
- Dense area of crown is opened to more light & air
- Lateral growth is encouraged, vertical growth reduced

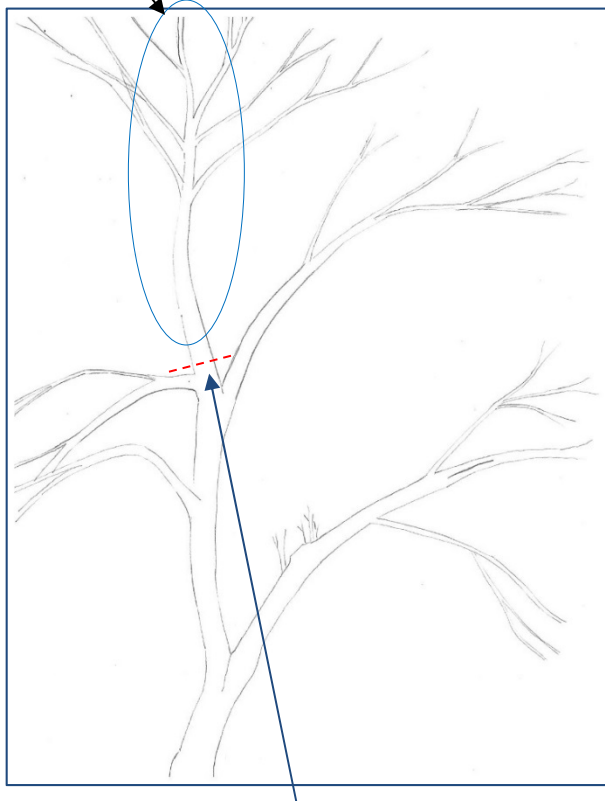
Tall vertical leader. This portion of stem doubles the height of the tree.

Bruce started his instruction by pointing-out the tree had directed more growth in the vertical direction than is desirable. His recommendation was to remove the tall vertical leader. This would return emphasis to horizontal structure and open light to the central portion of crown.

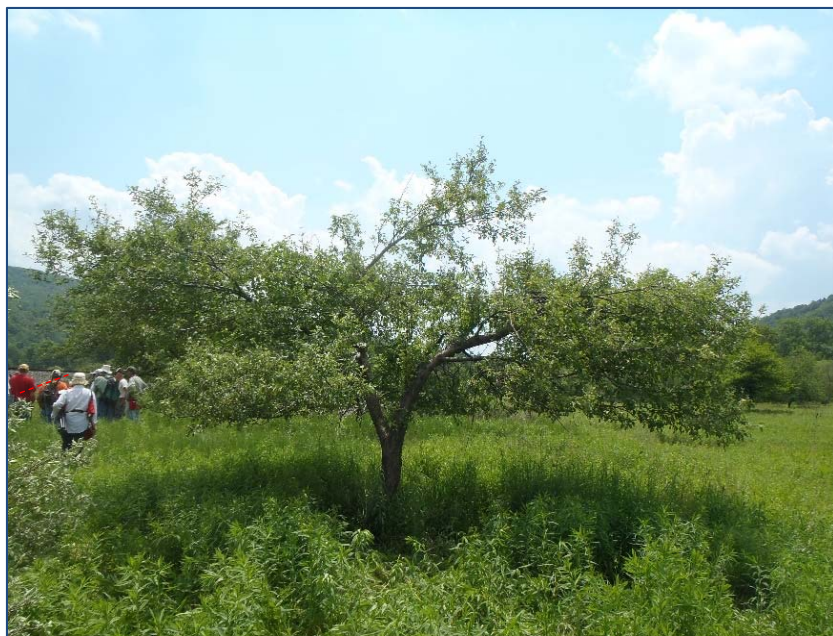
The final removal cut was made just above the union with a lateral branch.

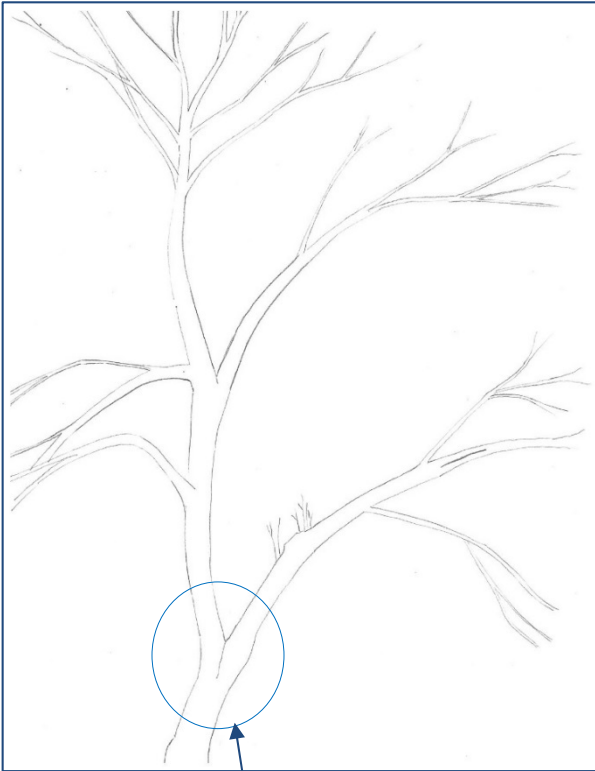
A single removal cut has completely changed the crown structure. It almost looks like a different tree. Sunlight will now more easily reach the central portion of the crown. A flush of new growth in this area is a likely response. The crown will fill-out and the 'flat-top' look will begin to fade next growing season.

There is more work to do on this tree (See Next Page) but this initial cut removed a large portion of the crown. It is not advised to remove more than 30% of the crown during a single pruning (less is preferable).

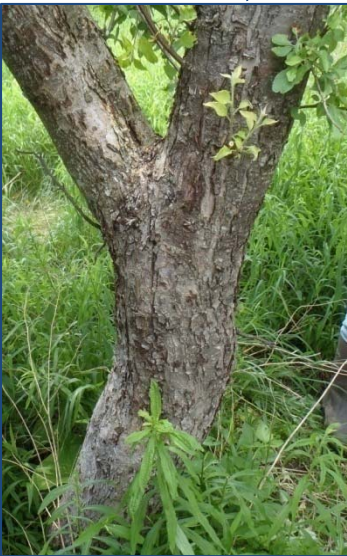
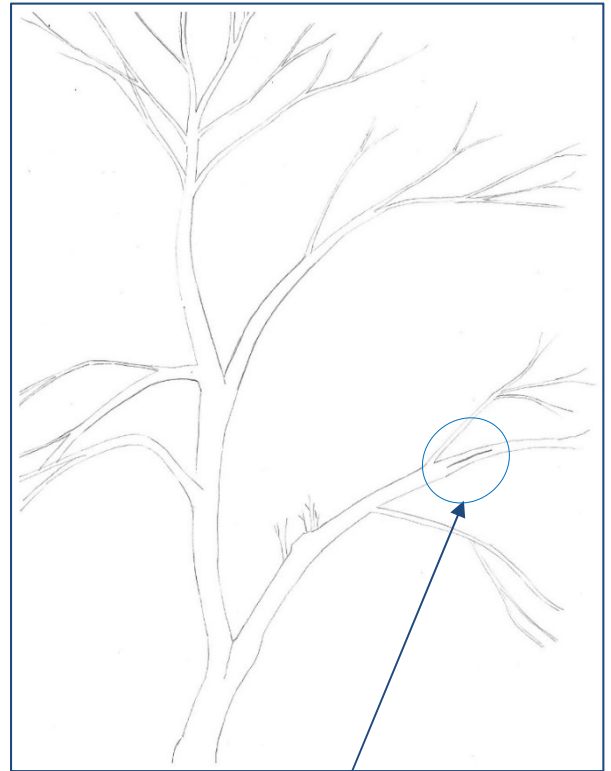
This narrow union has a vertical seam indicating structural vulnerability.

A heavy load on either side of crown may cause the seam to split and one side or the other to tear-off

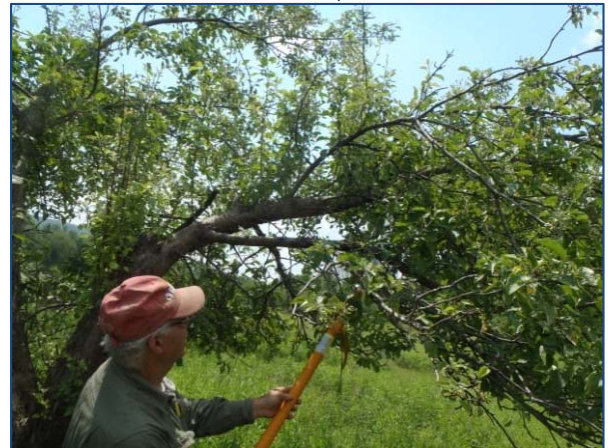
Bruce points to a stress crack that runs parallel the length of branch. This is a structural concern and potential entry point for wood decay fungi

Bruce suggests that future pruning work might focus on reducing the right side of the crown. Removing the entire right-side leader isn't necessary. Complete removal would reduce the tree's ability to produce and store energy. The loss of so much crown would likely cause a great deal of stress on the tree. However, leaving the entire right-side of the crown keeps the weak union (at the fork) vulnerable to the potential of heavy loading forces from wind, snow, and ice. Pruning to reduce weight and crown surface area will minimize potential for structural failure. Structural failure at large unions usually leads to the formation of large cavities and the eventual breakage and loss of everything above the cavity. Work on the right-side of the crown must wait for a season or two so the tree can recover and adjust to the pruning work just completed on the left-side of the crown. Bruce also points-out that the tree's response to this season's pruning will help guide subsequent treatments.

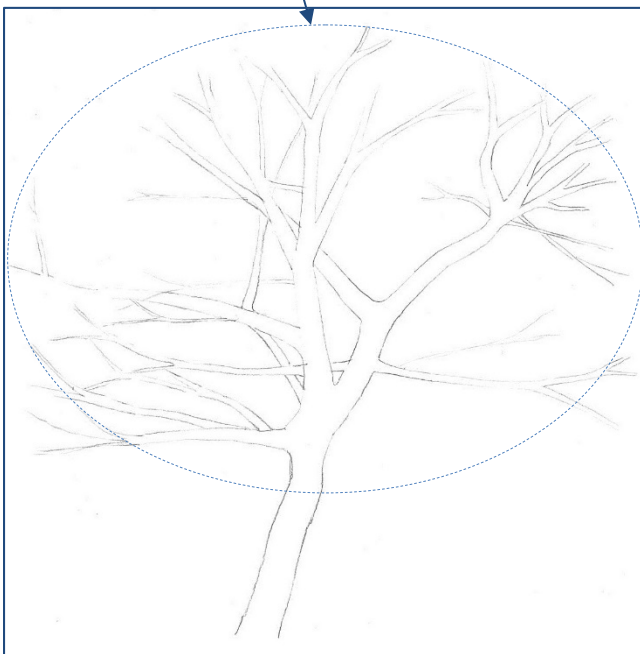
The team working-on this tree took several minutes to look it over and decide what, if any, work was needed. They concluded that the overall form of the crown was already pretty good. However, there were some structural issues amongst the branches. Also, the crown was overly dense; less than ideal for fruit production.

This tree's crown already had good general form; crown spread was a little more horizontal than vertical.

1. Decrease the density of the crown for better light and air circulation.
2. Eliminate crossing branches and provide adequate spacing to avoid rubbing injuries and structural problems.

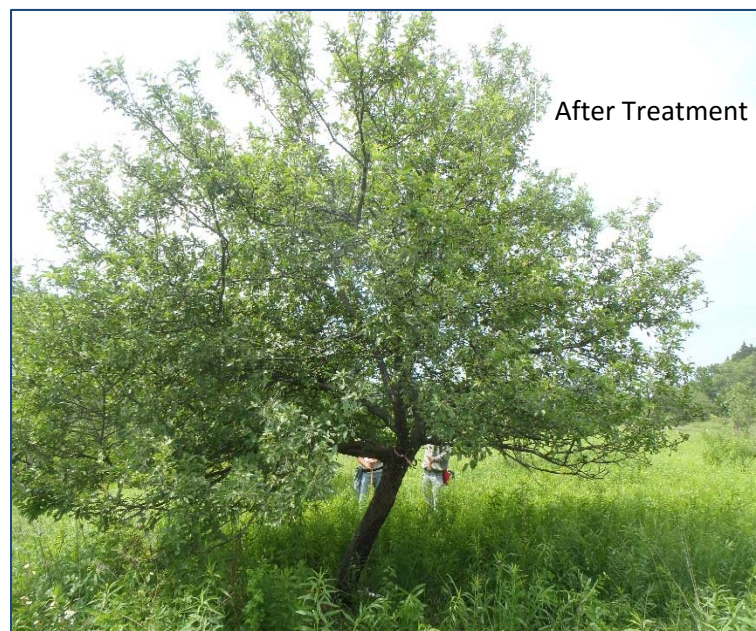
The foliage of this tree was very dense and a much closer view was required to see what work was really needed. The following page takes a closer look from within the crown. The pruning goal was to reduce crown density while eliminating structural problems at the same time. (See next page)

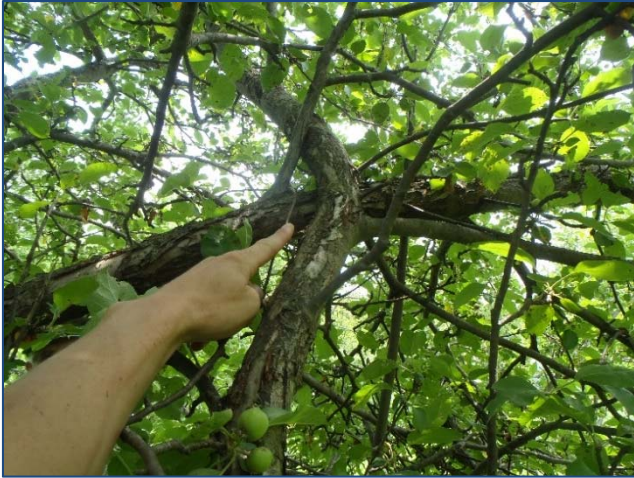
A noticeable change in crown density was accomplished without changing the crown's form.

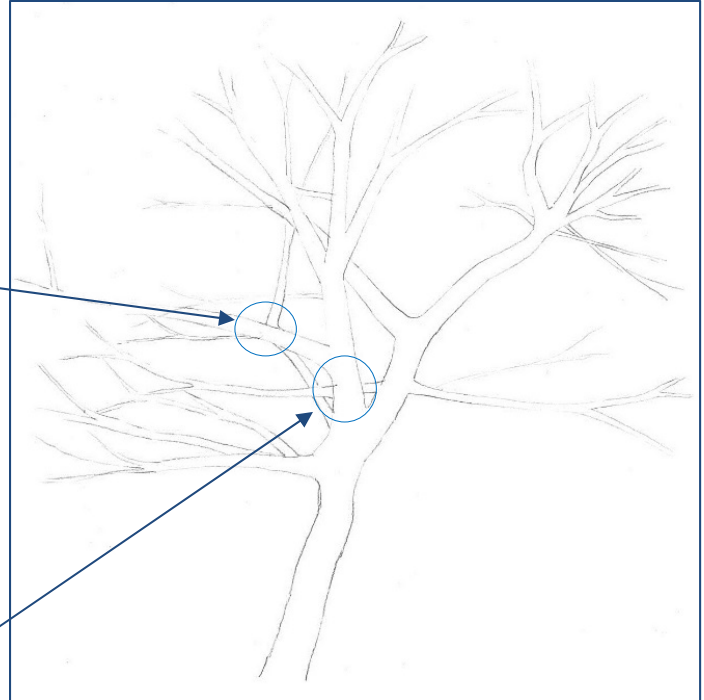
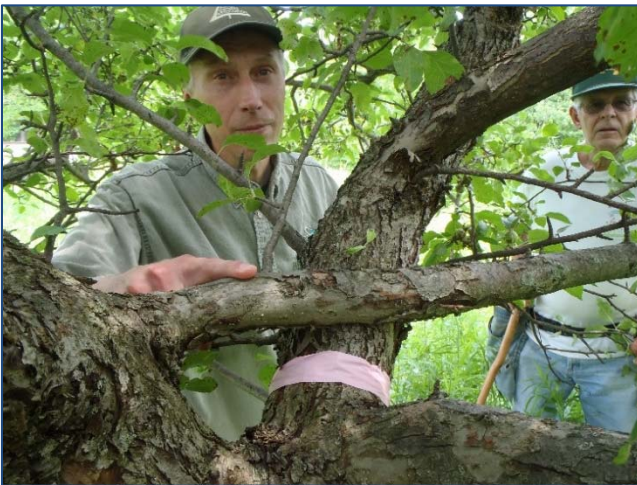
This branch was removed because it was contacting a better branch and competing for light higher in the crown. (Picture from backside of tree)

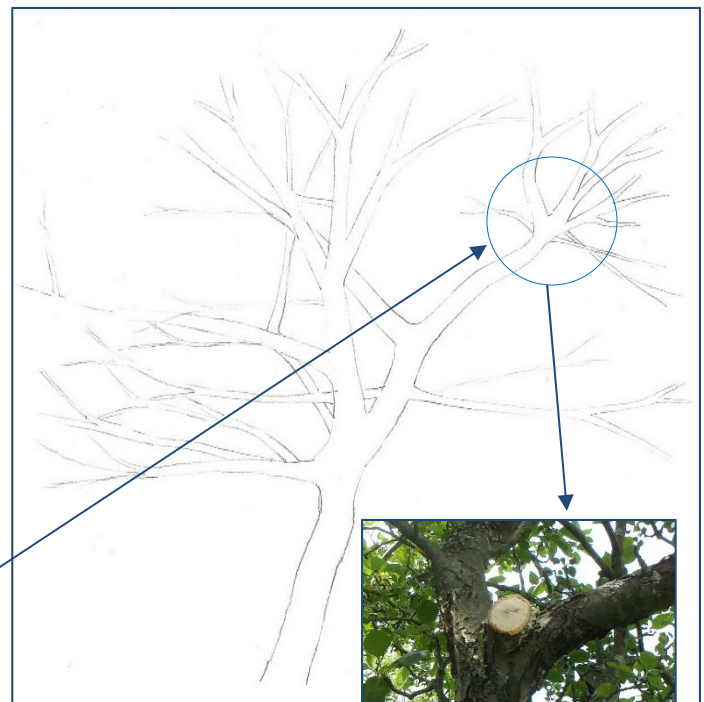
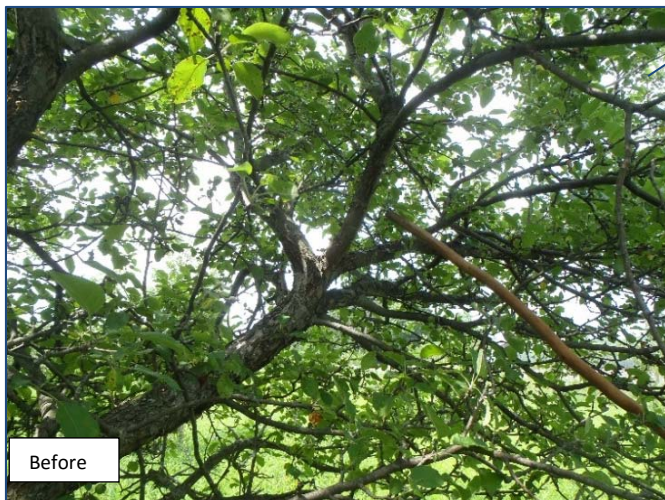
Another crossing branch. Bark injury occurred where the branches were in contact.

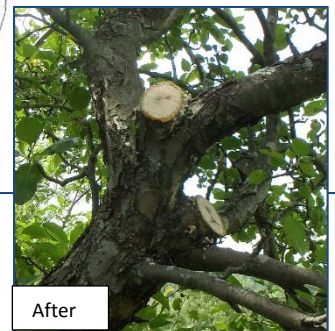
Before

Numerous lateral branches were crowding this portion of the crown. Two branches were removed in order to provide better spacing while also reducing crown density.
