This young sapling presents an opportunity to correct some structural concerns with much more ease than in the future when it would be larger & taller.

This tree is much older and larger than the one portrayed in the first example (Fall Newsletter). Larger trees generally require more work to correct problems and redistribute the shape of the crown as desired. Multiple rejuvenation pruning treatments are needed for this tree, and it will take several years to complete. Ideally, pruning to correct problems should be started when the tree is younger and smaller.

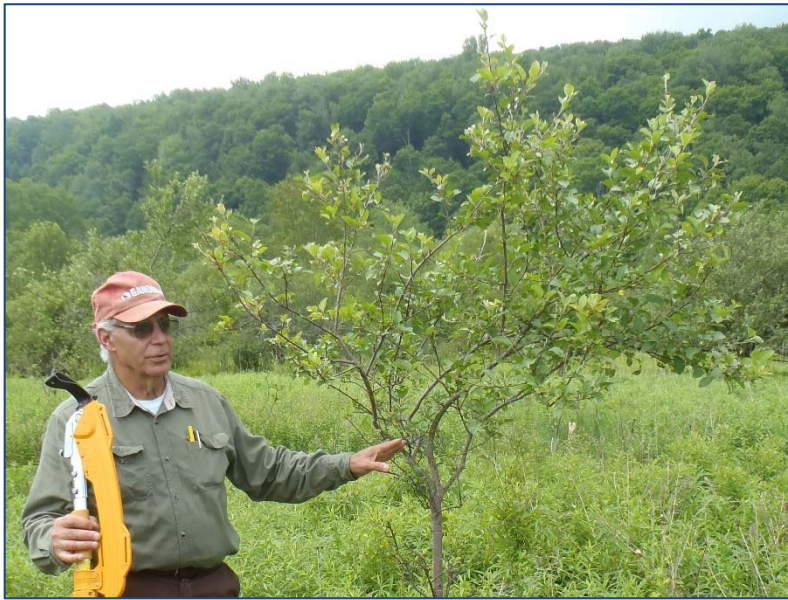
To begin, Bruce points-out that the tree has favored using its energy toward vertical growth rather than lateral growth. Lateral growth is more conducive to producing fruit when a tree has plenty of space like this one. His recommendation is to shift this balance, and also reduce the dense concentration of growth near the center of the crown.

The next step is to determine how to best accomplish these goals with as little stress on the tree as possible. After close examination Bruce found a bad union between two of the more dominant stems. One or the other needed to be removed to avoid structural failure in the future.

Dense growth in the central part of crown. The tree has favored growth in the vertical direction. More Lateral growth is preferable for fruit production.

By removing the co-dominant stem on the right multiple things are accomplished:

- Chances of structural problems & breakage at the union are reduced
- Dense area of crown is opened to more light & air
- Lateral growth is encouraged, vertical growth reduced
